Aquatic vegetation assessment of Scatter Bar Pond and Collins Bay in relation to herbicide treatments

Rich Miller and Mark Sytsma, Portland State University Center for Lakes and Reservoirs
February, 2018

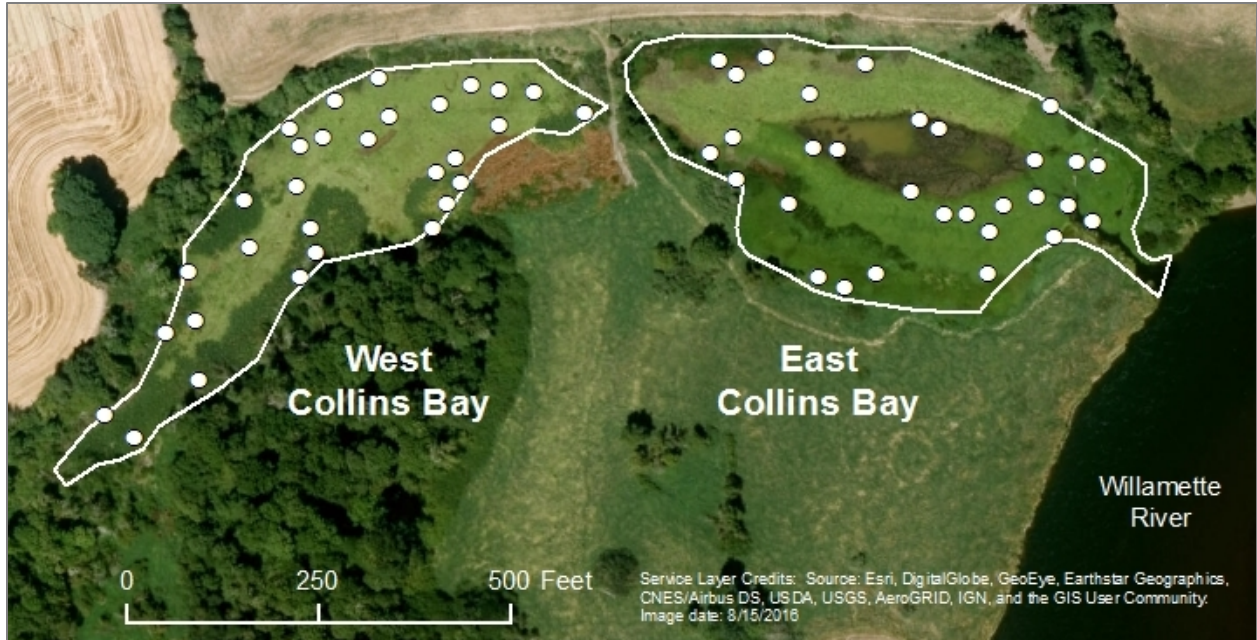
Figure 4. Points randomly selected for aquatic surveys within the Collins Bay survey area (white lines) during 2017.

During each sampling event aquatic plants were sampled at 60 pre-selected random points in each waterbody survey area (Figure 4, Figure 5). Collins Bay sample points were evenly divided between the east and west ponds. Random sample sites were selected so samples would be representative of each survey area. ArcGIS was used to define survey area boundaries from National Hydrography Dataset waterbody boundaries (US Geological Survey 2013) edited to match LiDAR elevation data (DOGAMI 2018). Random points located a minimum of 8 m apart within survey areas were selected using the ArcGIS Sampling toolset. Points were loaded onto a Trimble Juno 3b GPS unit with ArcPad 10.2 software prior to field sampling.

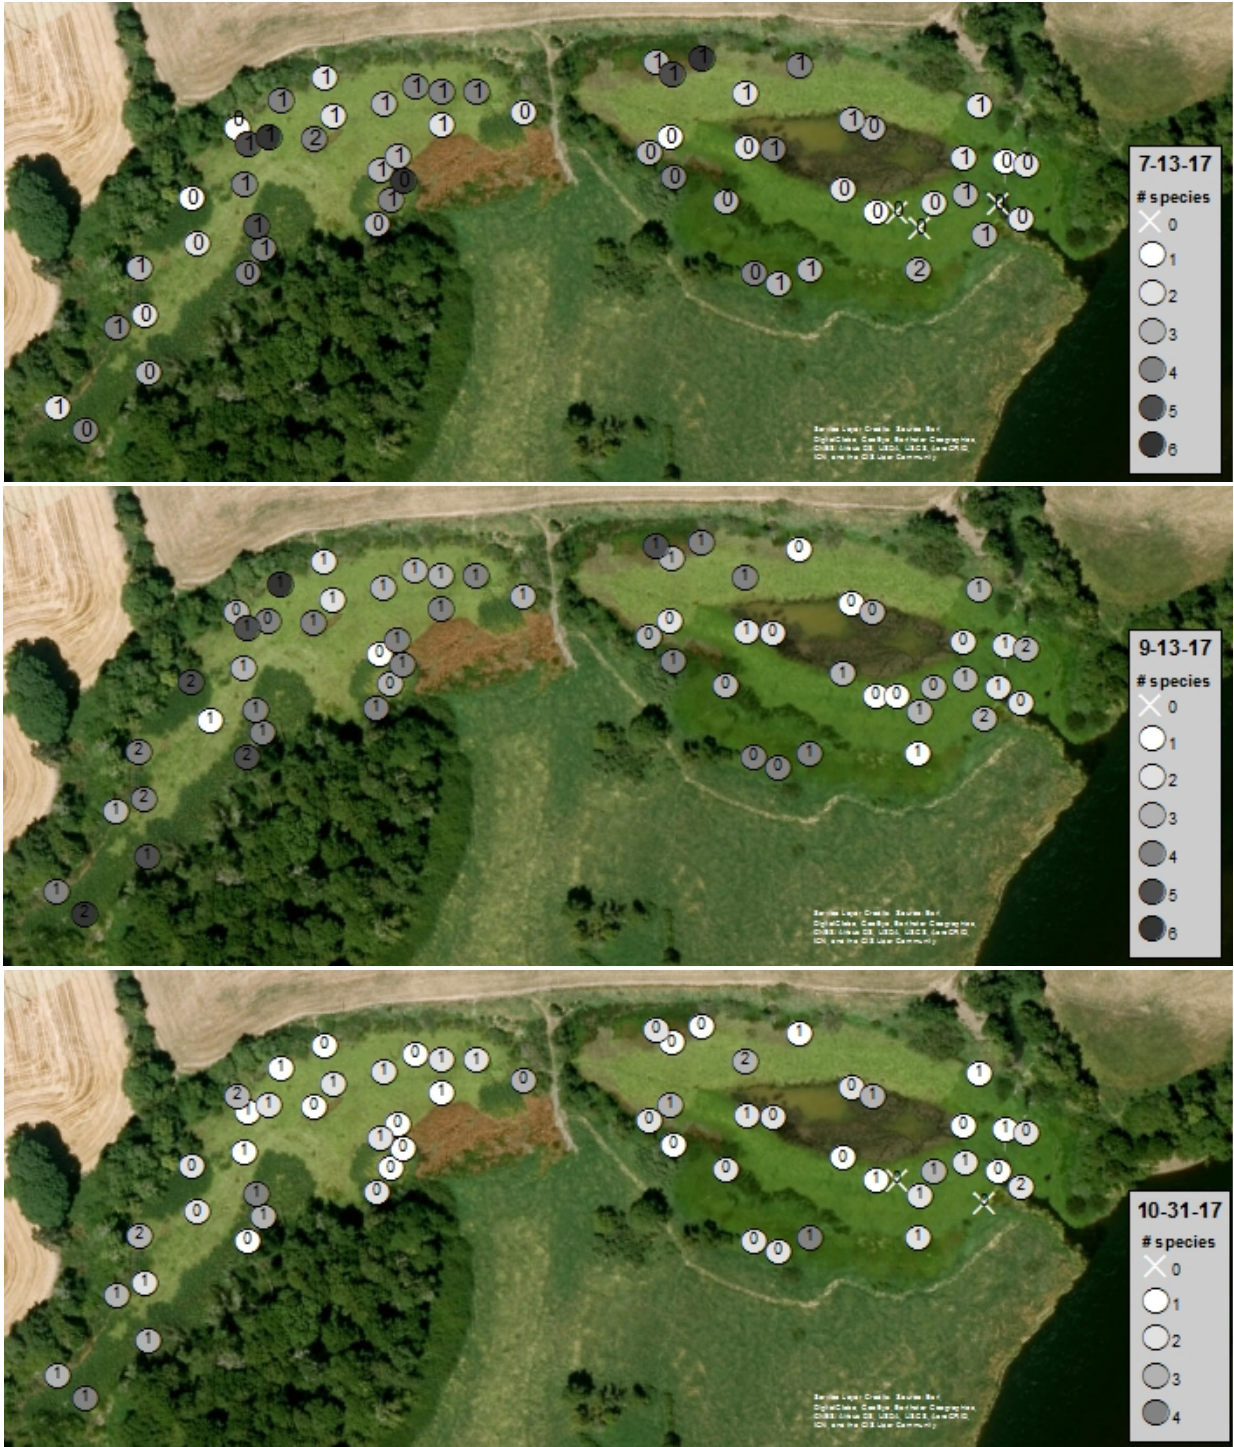
Figure 8. Total species richness (colors) and aquatic invasive species richness (numbers on top of points) observed at Collins Bay during 2017.

Twenty-nine aquatic plant species were recorded at Collins Bay, seven of which were non-native species (Table 2). Up to six total and two non-native species were recorded at each site (Figure 8). *Ludwigia hexapetala* was present at between 42 and 58% of the sites during sampling events, although at low densities. The *L. hexapetala* density index was less than 25 at more than 51% of the sites and greater than 75 at less than 6% of the sites with *L. hexapetala* was present during all sampling events (Figure 9). Parrotsfeather (*Myriophyllum aquaticum*), the next most common non-native species encountered, was present at between 8 and 13% of the sites (Figure 10). Native aquatic plants were diverse and widespread and included wapato (*Sagittaria latifolia*), northern water plantain (*Alisma triviale*) and spatterdock (*Nuphar polysepala*) (Figure 11). Coontail (*Ceratophyllum demersum*) was the most commonly encountered native submersed species. The non-native submersed species Brazilian elodea (*Egeria densa*) and curlyleaf pondweed (*Potamogeton crispus*) were present, but rare, in the eastern pond. Depths ranged up to 3 m in the eastern pond during the October sampling event (Figure 12). Much of the center of the western pond was covered with a floating island comprised of dead *L. hexapetala* biomass.

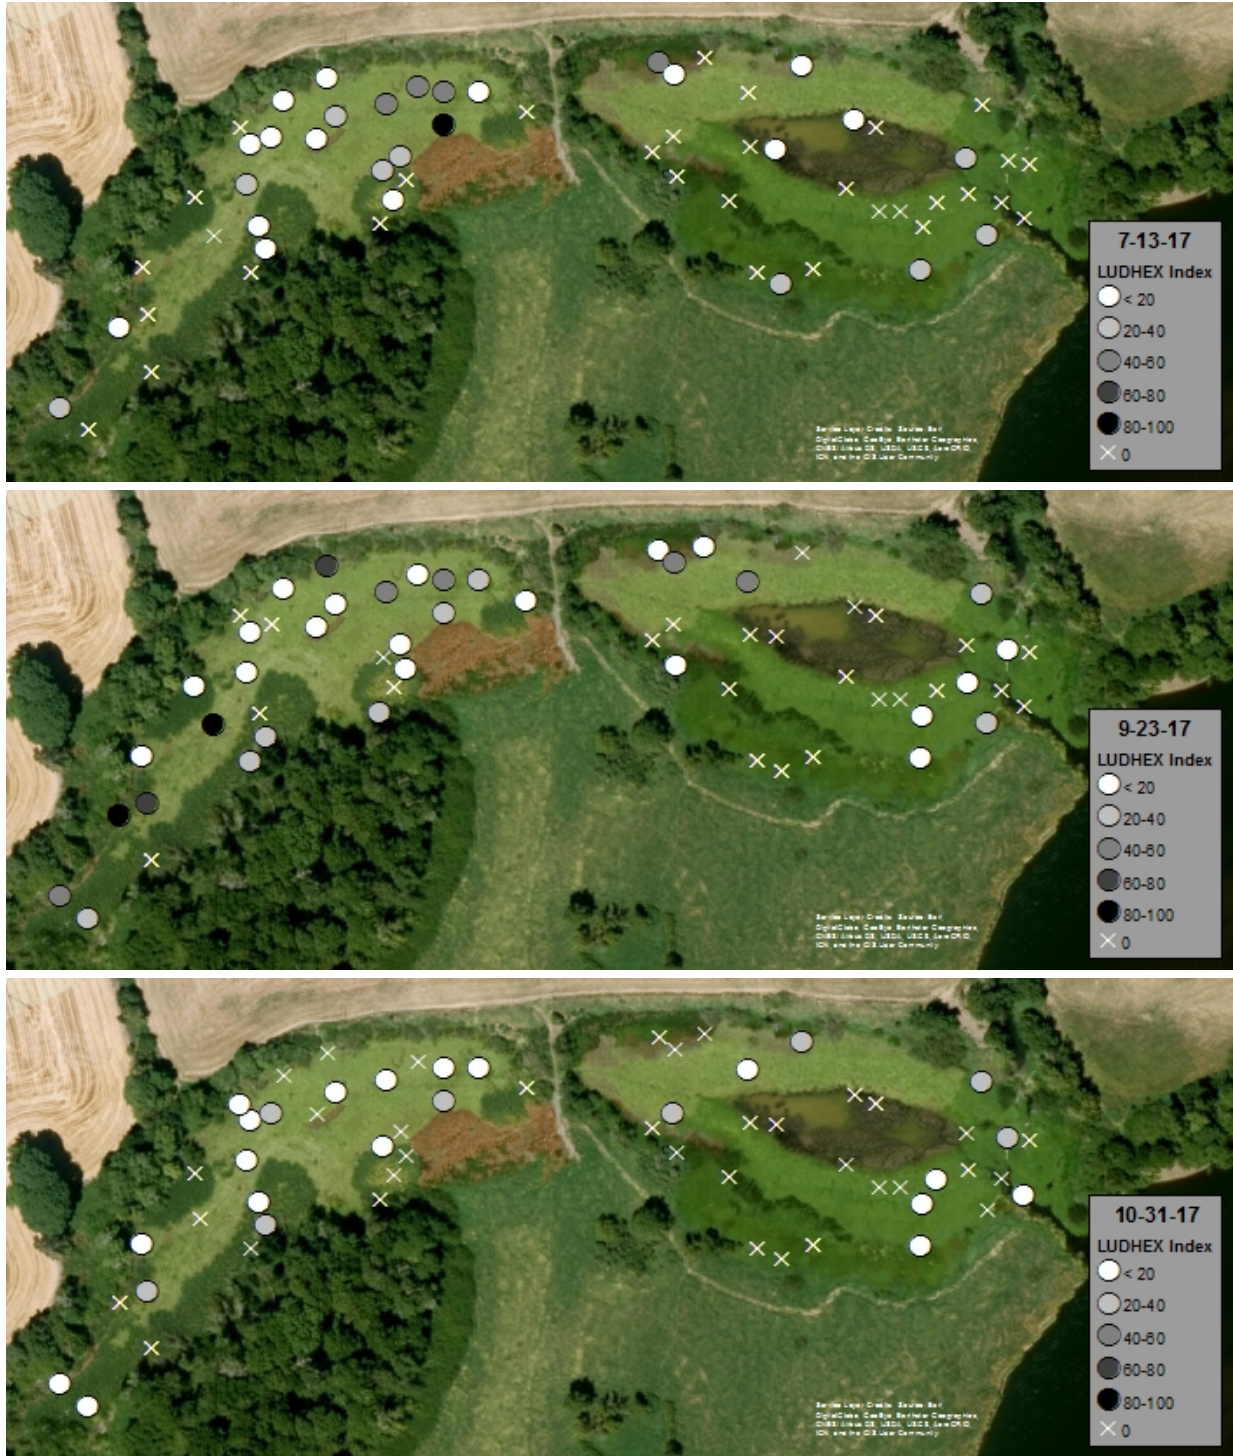
Figure 9. *Ludwigia hexapetala* density index categories at Collins Bay observed during 2017 sampling events.

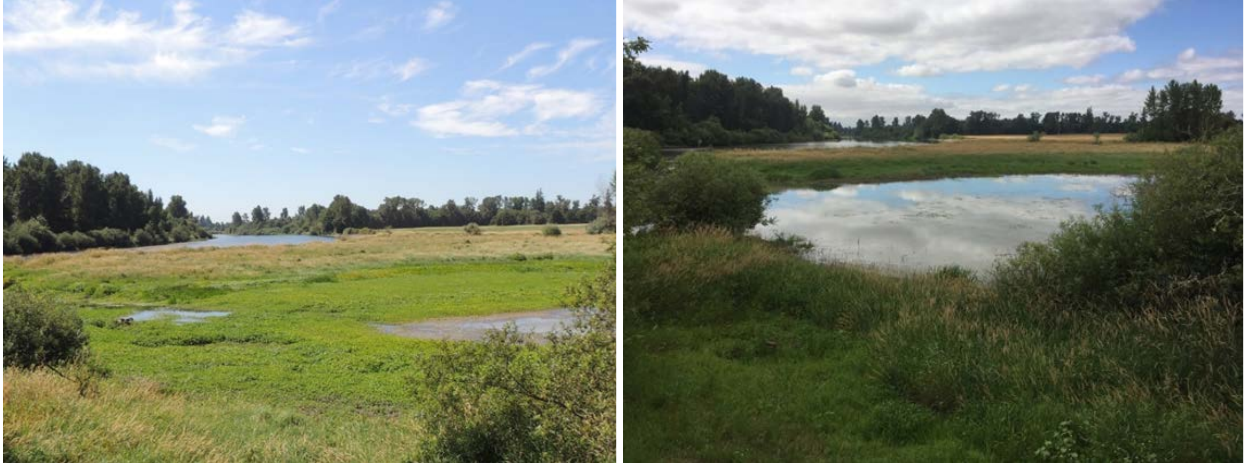
The aquatic plant communities at Scatter Bar Pond and Collins Bay were strikingly different during the 2017 surveys. At Scatter Bar Pond *L. hexapetala* was the dominant species in terms of both frequency of occurrence and density. At Collins Bay *L. hexapetala* occurred less frequently, was less dense, and the aquatic plant community was more diverse. This difference, particularly the difference in density, is likely due to the three previous years of herbicide treatments. Although there was no pre-treatment aquatic plant community assessment, Benton SWCD's photo monitoring illustrates large declines in the Collins Bay *L. hexapetala* population since herbicide treatments began in 2014 (Figure 13).

Figure 13. East Collins Bay Pond from Benton SWCD Photo Point 4 looking east showing pre-treatment conditions with extensive *L. hexapetala* beds (left, July 7, 2014) and 2017 conditions with reduced beds (right, July 7, 2017).

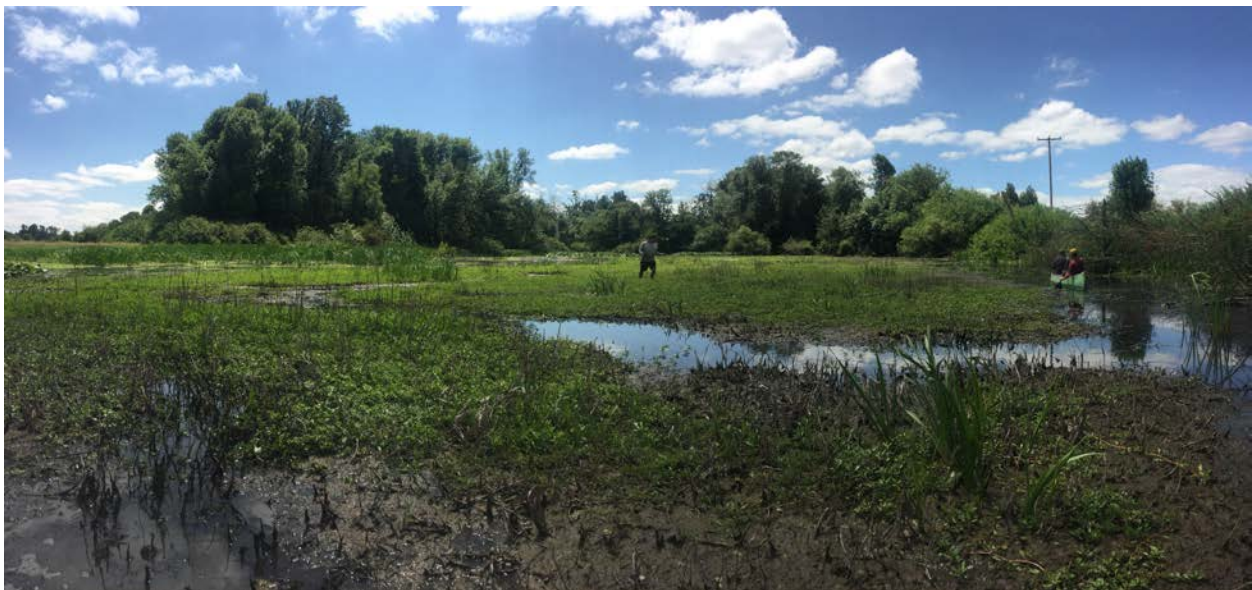
Recovery of the deeper portions of the western Collins Bay pond was hampered by the presence of the extremely dense floating mats of dead *L. hexapetala* (Figure 14). This mat provides substrate for native wetland species growth, but also substrate for growth of *L. hexapetala* in areas that would be too deep for *Ludwigia hexapetala* without the floating mat. Removal of floating mats is recommended using a backhoe, grab dredge, weed cutter (e.g. www.aquarius-systems.com/pages/55/cutters.aspx), or manual cutting and removal (City of Eugene Parks and Open Space Division 2013).

Figure 14. Floating mats at West Collins Bay Pond on September 8, 2017. View towards the southwest with sparse growth of *Ludwigia hexapetala* and *Sparganium emersum* on floating mats.
